How to Fix Keurig K75 Platinum Brewing System Water Pump Leak

This guide will show you how to fix internal water leaks for the Keurig B70 Platinum Brewing System.

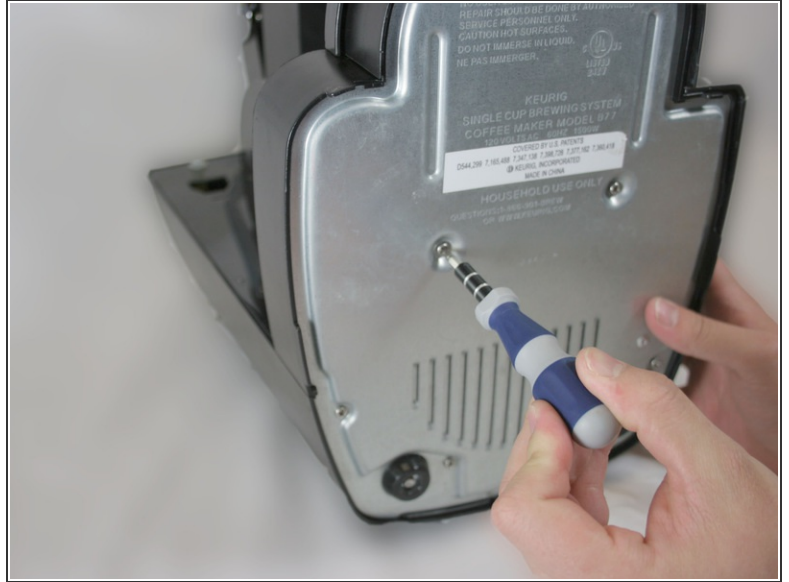
- Move the brewer so that the metal baseplate is easily accessible.
- Remove the five silver 4 mm Phillips #2 screws from the baseplate.

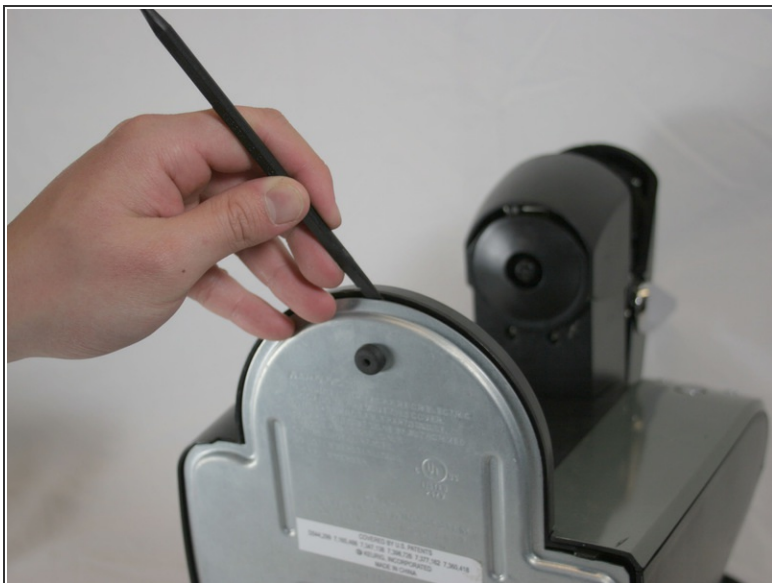
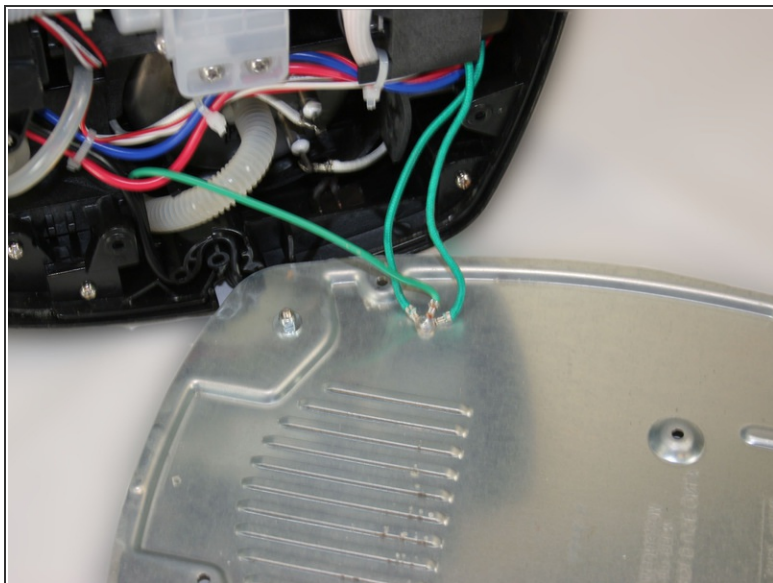
Step 2

- Using a spudger, gently pry the metal baseplate from the brewer.
- Gently set down the baseplate.

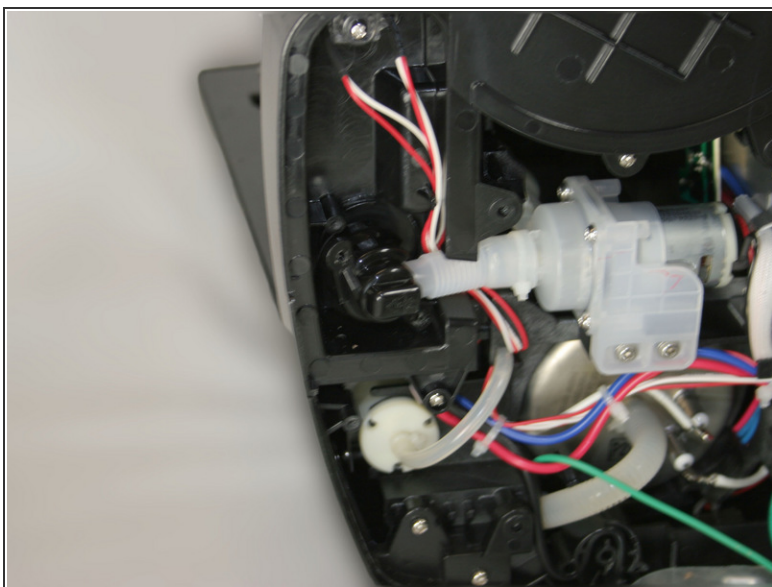
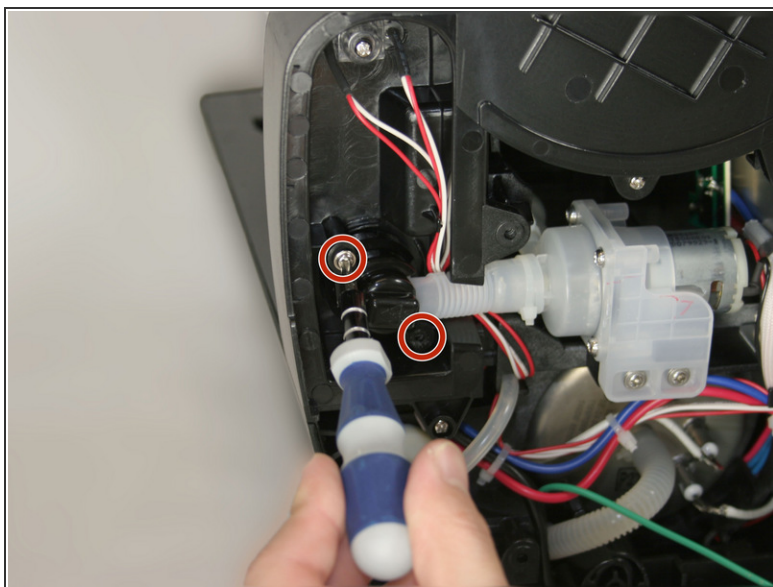
Step 3 — How to Fix Keurig K75 Platinum Brewing System Water Pump Leak

- Remove the two silver 4mm Phillips #2 screws that hold the water pump in place.

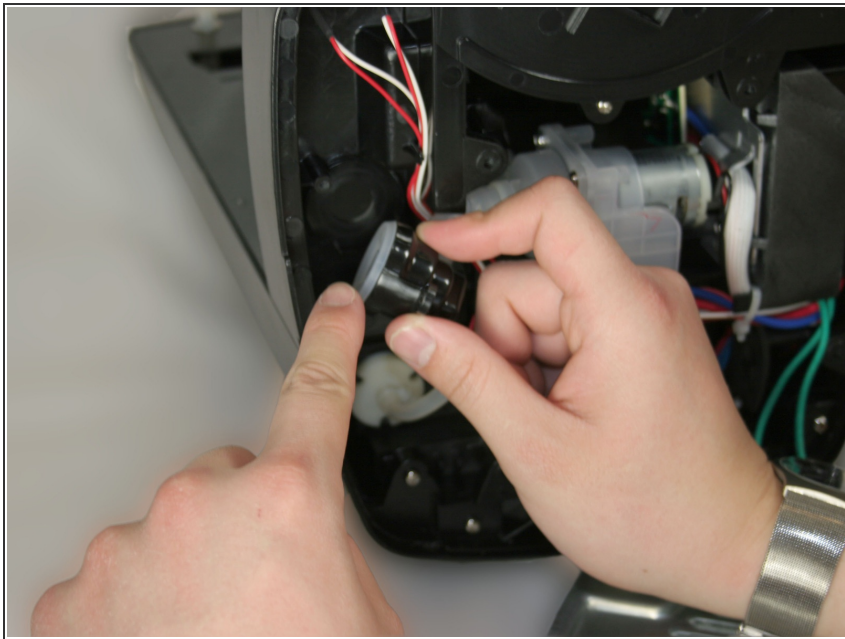
Step 4

- Realign the rubber gasket of the water pump to create a tight fit.
